Lough Feeagh, Mayo, Geophysical Survey Report

Project	Lough Feeagh Geophysical Survey
Survey date	28/01/2023 and 27/03/2023
Survey location	Lough Feeagh, Mayo
Survey type	Sub-Bottom-Profiler
Report date	30/03/2023
Location	Lough Feeagh, Mayo
Coordinate system	ITM

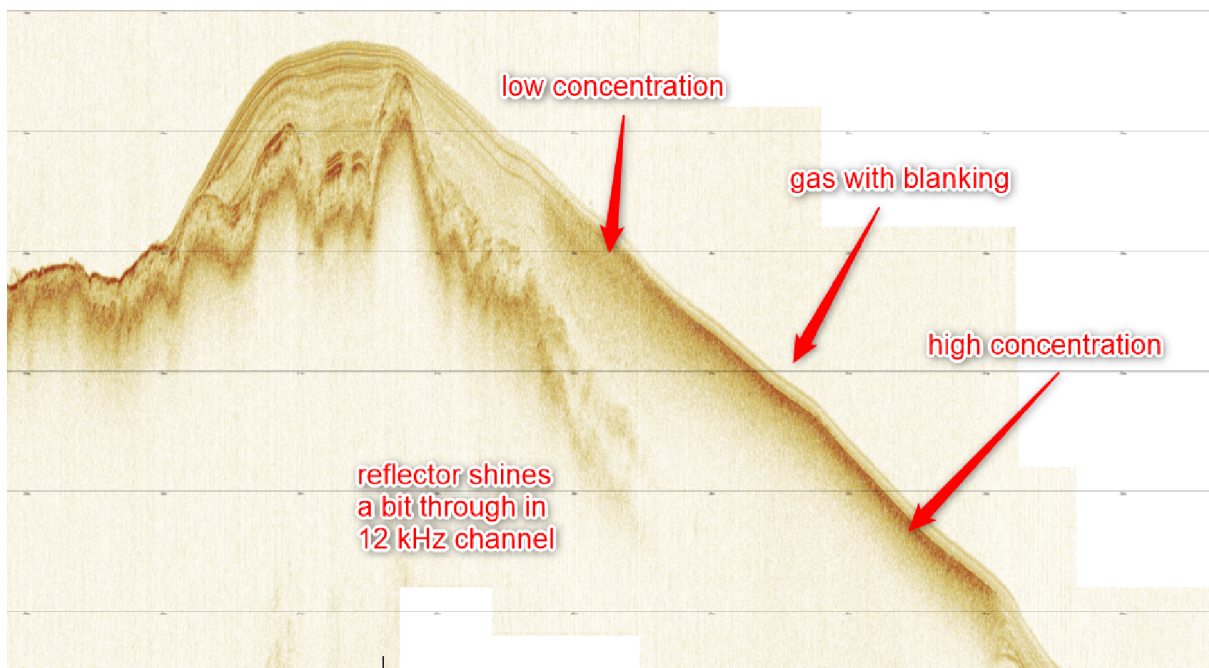
Figure 1. A good example of a profile showing rock head, silt layers and gas blanking.

Data quality was very good in general, with what has been interpreted as rockhead visible in the south of the survey area, overlain by clear layers of sediment. Penetration was poor in some areas due to blanking from gas from organic matter in the silt. We can clearly see areas of high and low concentration gas and these areas could be mapped if required. We see predominantly exposed and shallow rock on the south end of the lake and gas blanking from the centre to the north end. It would be interesting to plot available cores onto the seismic profiles.

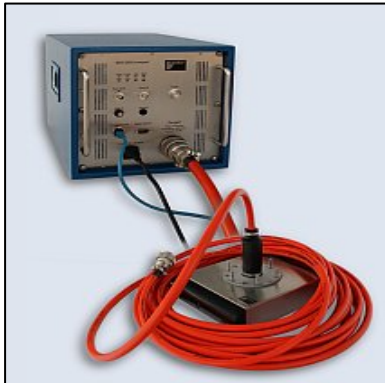
Figure 3: SES Innomar 2000

The seismic data were collected with INNOMAR SES-2000 parametric sub-bottom profiler (Figure 2). It was operated at high (12kHz) and low (6kHz) secondary and 100kHz primary frequencies and is suitable for shallow water depths, as in the survey area.

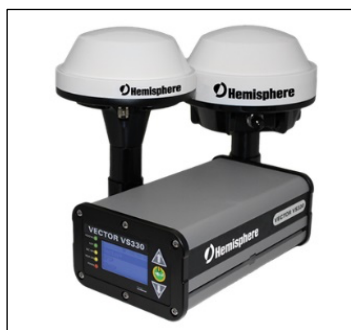
Figure 4. VS330 GNSS compass.

Vector VS330 GNSS compass was used to give RTK position and heading to the survey vessel and as a sensor for the Innomar system (Figure 3).
